# The World Trade Center Destruction and the Role of the Quoted Expert

by **Dr. Louis F. Geschwindner Jr.**, *New York Gamma '67*, P.E., and **Charles J. Carter**, *Pennsylvania Beta '90*

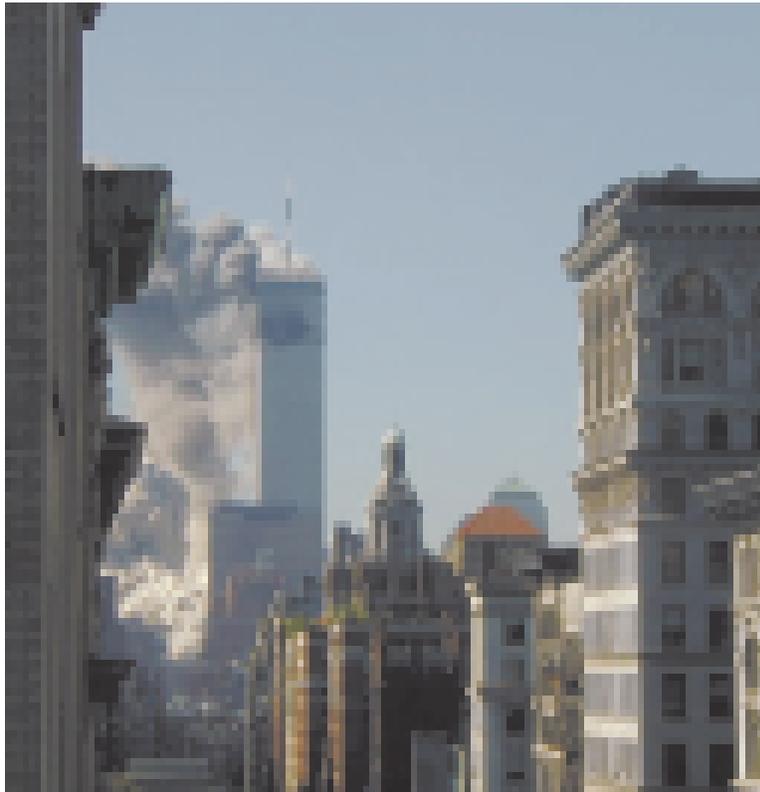
The World Trade Center Towers are struck. . .

At 8:48 a.m. on September 11, 2001, Tower 1 was hit from the north by an American Airlines Boeing 767 carrying 92 people and approximately 14,000 gallons of jet fuel. The impact occurred between approximately the 92<sup>nd</sup> and 95<sup>th</sup> floors, approximately 200 feet from the top. It appears that the impact severed two-thirds of the 61 columns on the north face as well as several floors at the impact site.

At 9:03 a.m., a United Airlines Boeing 767 with 65 people on board hit Tower 2 from the south at levels 78 to 84, approximately 400 feet from the top and also severing approximately two-thirds of the columns on the south face. Again, several floors at the level of impact were destroyed in the area of impact. Presumably, the structure in the building core was also damaged, but the full extent of that damage may never be known. It is also likely that there was damage to the perimeter columns on the faces opposite to those into which the planes collided because some portions of the plane penetrated completely through the buildings.

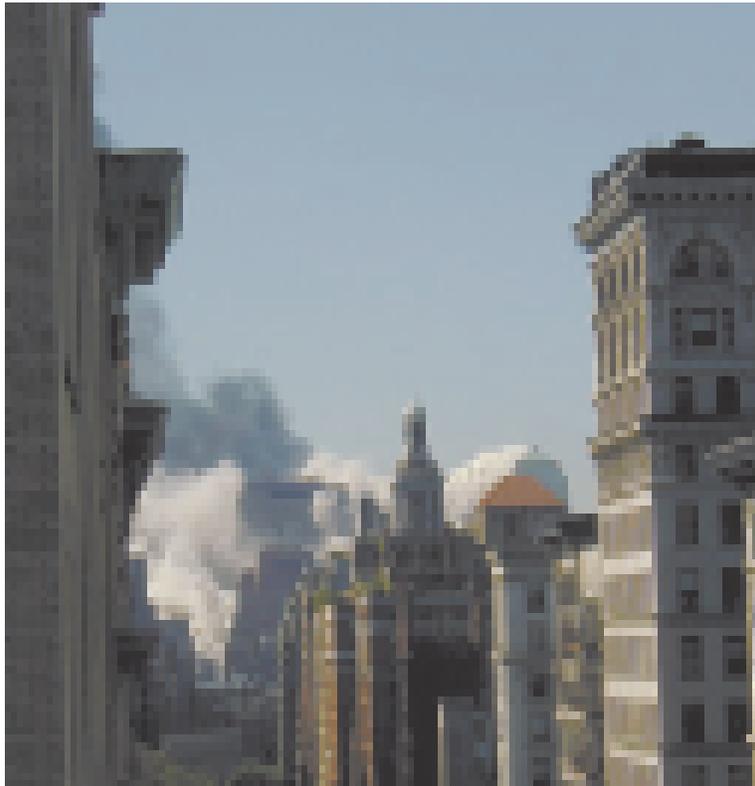
...and Collapsing. Two of six shots by Peter Girgis at NBBJPhotos.

Explosions upon impact further weakened the structures. Jet-fuel-fed fires burned over multiple floors in both buildings, and at 9:59 a.m., Tower 2 collapsed. A review of video footage and several still photos indicates that the upper levels of this tower first leaned to the southeast, toward the damaged face of the tower. This tower section then appears to have straightened and, with a small clockwise rotation, initiated the progressive collapse and total destruction of the tower. Essentially, this was tantamount to a 30-story building falling onto a 70-story building.

At 10:28 a.m., Tower 1 collapsed. Again, a review of video footage indicates that the upper levels of the tower progressed fairly straight down as could be seen by observation of the collapsing structure and positioning of the rooftop antenna during the collapse. Much like the collapse of Tower 2, the collapse of Tower 1 was tantamount to a 10-story building falling onto a 90-story building. Although both towers appeared to collapse straight down, falling in on themselves, subsequent investigation at the site has shown that there is extensive damage to surrounding buildings as a result of falling debris.
