The Chesapeake & Ohio Canal — Marvelous Engineering Failure

by Dr. Arthur D. Delagrange, Massachusetts Beta '62

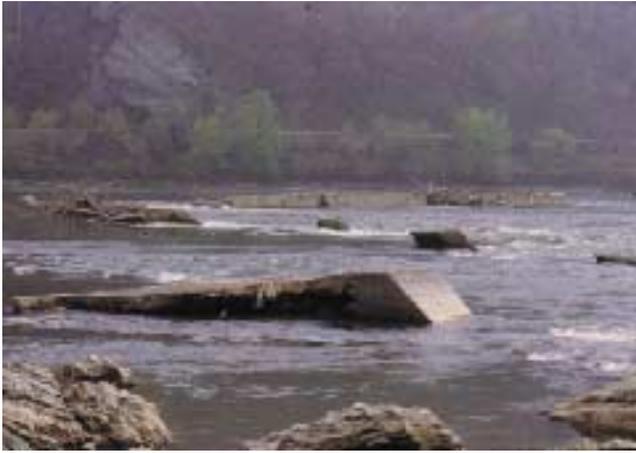
Ruins of dam #3, damaged in the flood of 1924 that closed the canal (milepost 64).

The river that was the lifeblood of the canal was also its nemesis, and ultimately destroyed it. With most of the forests in the drainage basin cleared, floods were a continuous problem. A severe flood in 1889 drove the company into receivership, and its principal stockholder, the B&O, took over its operation! An even worse flood in 1924 obliterated three dams, severely damaged a fourth, and caused much other damage. No one thought the canal worth rebuilding. Its near-century of troubled service was over. It had served well, but not well enough.

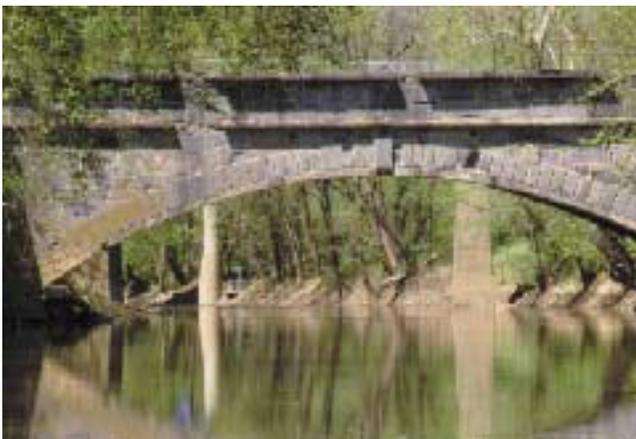
Three eras of transportation: the aqueduct is from the canal; the rectangular pillars are from the railroad (now also a hike/bike path); the round pillar is the present highway bridge (milepost 116).

The ditch was lined with clay to reduce leakage. Side creeks were not used. In fact, these were routed under the canal, necessitating stone aqueducts to separate the two channels. The locks had mammoth wooden gates, angled upstream so the 16-ton force of the water held them shut. They were operated by hand. A smaller gate had to be opened to fill or drain the lock to equalize the water level on either side of the big gate before it could be opened. It took 10 minutes for a boat to pass through a lock. The dams originally were timber frames filled with rocks and rubble, but leaked badly and later were replaced with concrete. The locks were made with huge stones cut precisely and laid without mortar, although farther up the river where good stone was scarce timber-sheathed walls were used, these being much more susceptible to damage from the barges. An extensive system of gates and channels was used to maintain the proper water level and slight downstream current in the ditch, or isolate the canal entirely when the river flooded. This was little help when the river level rose above that of the canal.

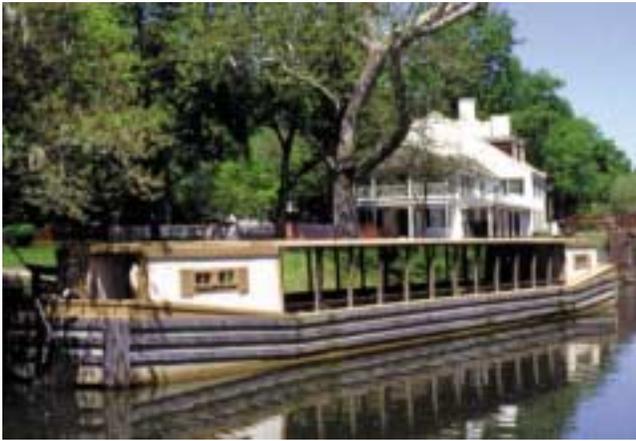
Replica canal boat on restored section of canal, modified to carry tourists. Great Falls Tavern is in the background. (milepost 14).

The round trip took two weeks (today, six hours by car). The canal boats were just slightly smaller than the locks themselves, which were 100 feet long and 15 feet wide, and of 4.5 feet of draft (the canal was specified as six feet deep, but tended to silt in). They could carry more than 100 tons in addition to having living quarters for the crew, typically the owner and his entire family, and stabling for alternating teams of animals. In the peak years there were more than 500 of these boats, hauling nearly a million tons of coal alone. (This becomes even more impressive considering that during cold weather, the peak demand for coal, the canal was likely to be out of service because of ice!) The boat crews, lock operators, repair crews, stablemen, innkeepers, and various other services along the canal constituted an entire subculture, and it was definitely not high society. Today most of the buildings are gone, destroyed by floods or simply abandoned, as generally there are no roads nearby.

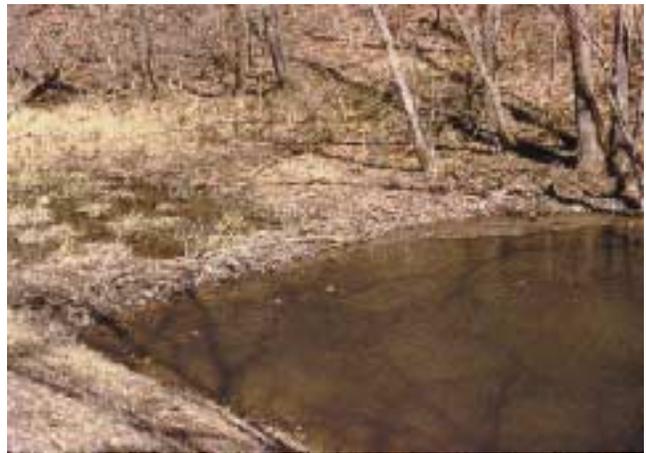
Nature succeeds where man fails: only this beaver dam keeps water in this section of the canal (milepost 155).

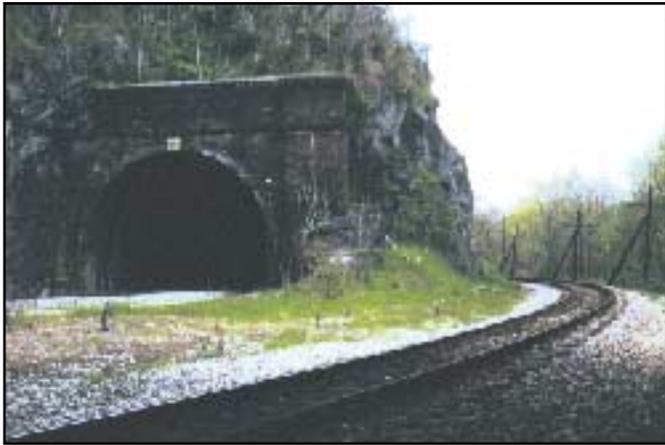
The final insult. When the new longer and taller railway cars wouldn't fit through the old double-track tunnel at Point of Rocks, one track was moved to the center of the tunnel and the now-defunct canal filled in for the other (milepost 49).

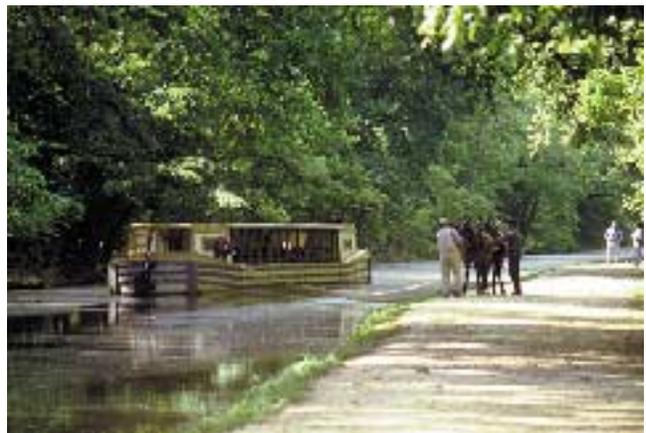
Replica canal boat being pulled along the canal by a team of mules (milepost 14).
